# Manhole Inspection Summary

Manhole # S33CC\_051MH

Insp Date: **3/1/07 10:43 AM**

**Location** Address: **223 CHASE ST**

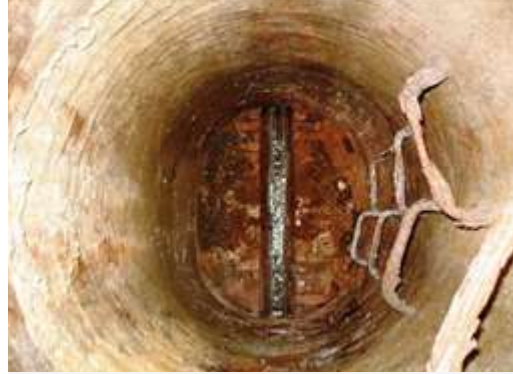
Top View

Corroded steps. Evidence of surcharge - Bench debris.

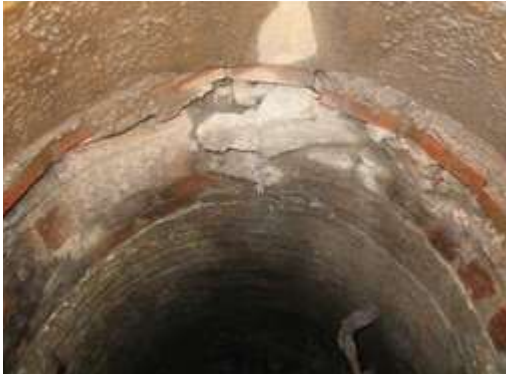
Defect

Frame leaks. Adjustment deterioration, loose brick and infiltration. Corbel infiltration.

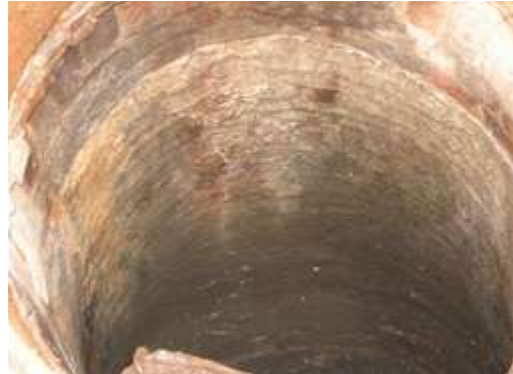
Defect

Adjustment and Corbel infiltration.

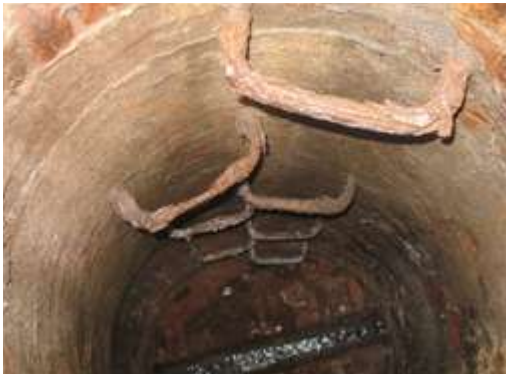
Defect

Corroded steps.

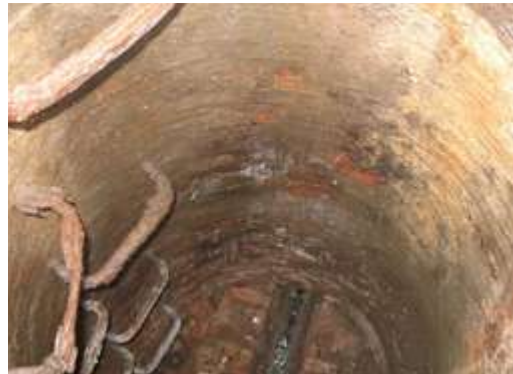
Defect

Corbel and Barrel infiltration.

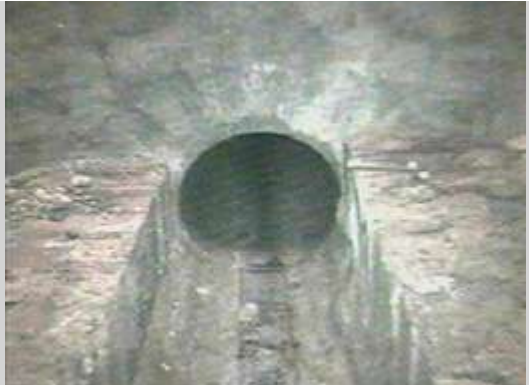
### 8 in. Circular Gravity Sewer Pipe Out @ 12 O'Clock

Invert Depth: **11.60** (ft.) Flow Characteristics: **Slow**

Infiltration: **None** Pipe Seal Cond: **Unknown**

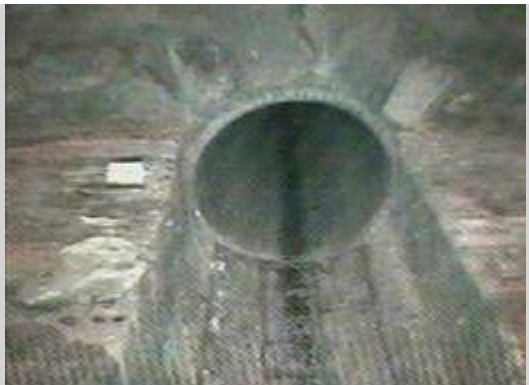
### 8 in. Circular Gravity Sewer Pipe In @ 6 O'Clock

Invert Depth: **11.50** (ft.) Flow Characteristics: **Slow**

Infiltration: **None** Pipe Seal Cond: **Unknown**
